Thomson Property Map

Created for the Environmental Quality and Sustainability Commission by Ian Yarbrough.
Photos by Ben Stidd of the Monroe County Soil and Water District

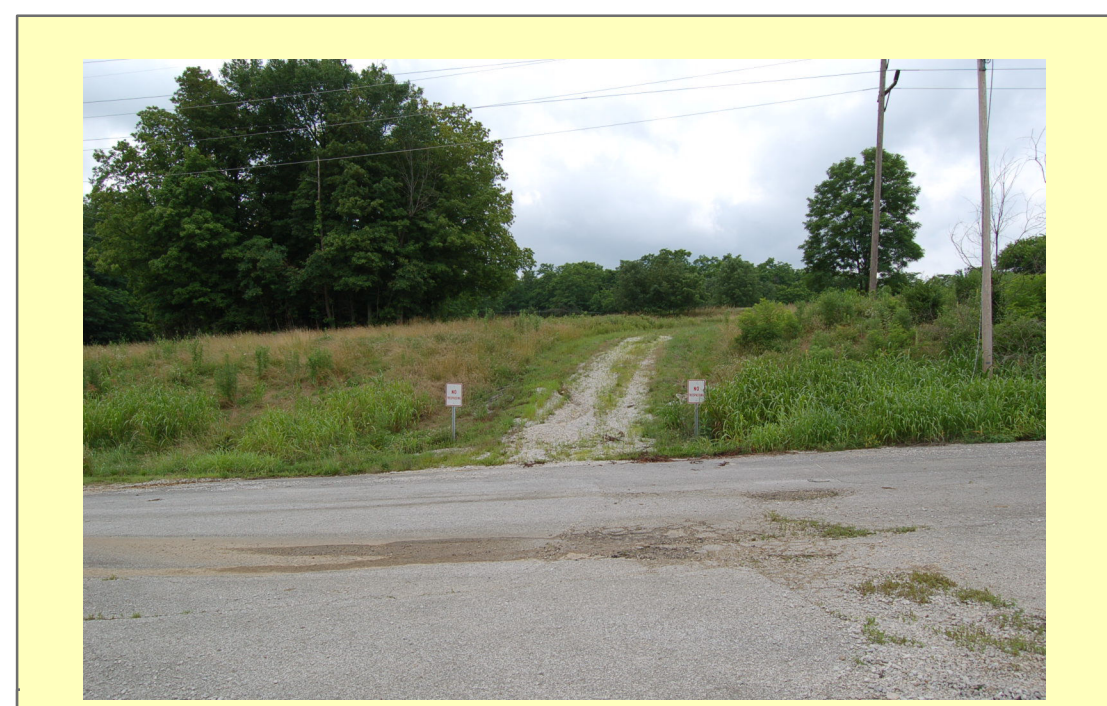
View from the Organized Living parking lot, looking south to the fenced in area. The fenced area is an open, relatively flat area characterized. There was formerly a house facility here, so some foundation material may remain.

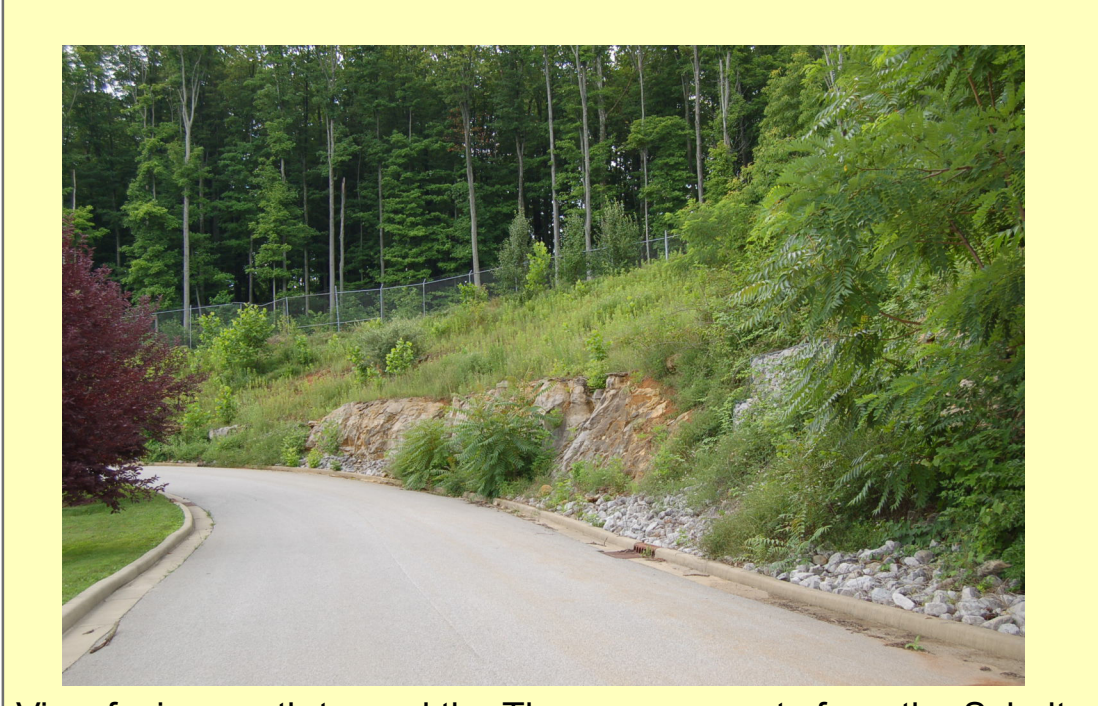
View facing south toward the Thomson property from the Schulte drive. This northern border of the property is significantly higher than the road and is separated by a fence.

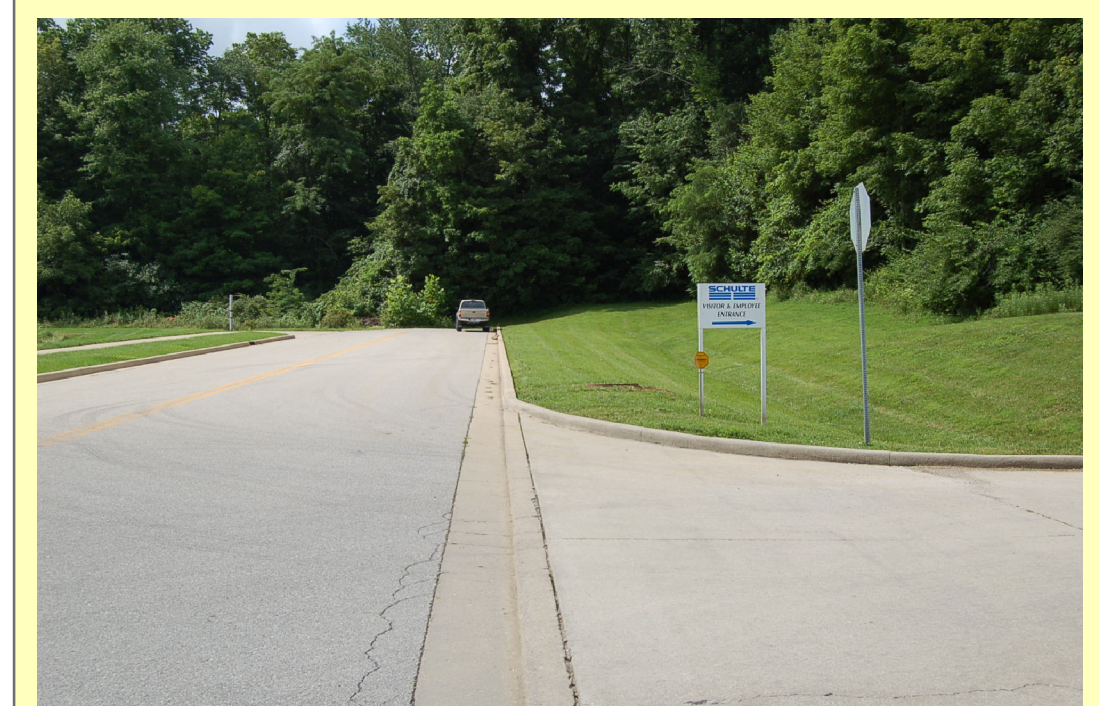
View from Strong Dr facing south toward the property. There is a small electric sub-station to the left of the road here.

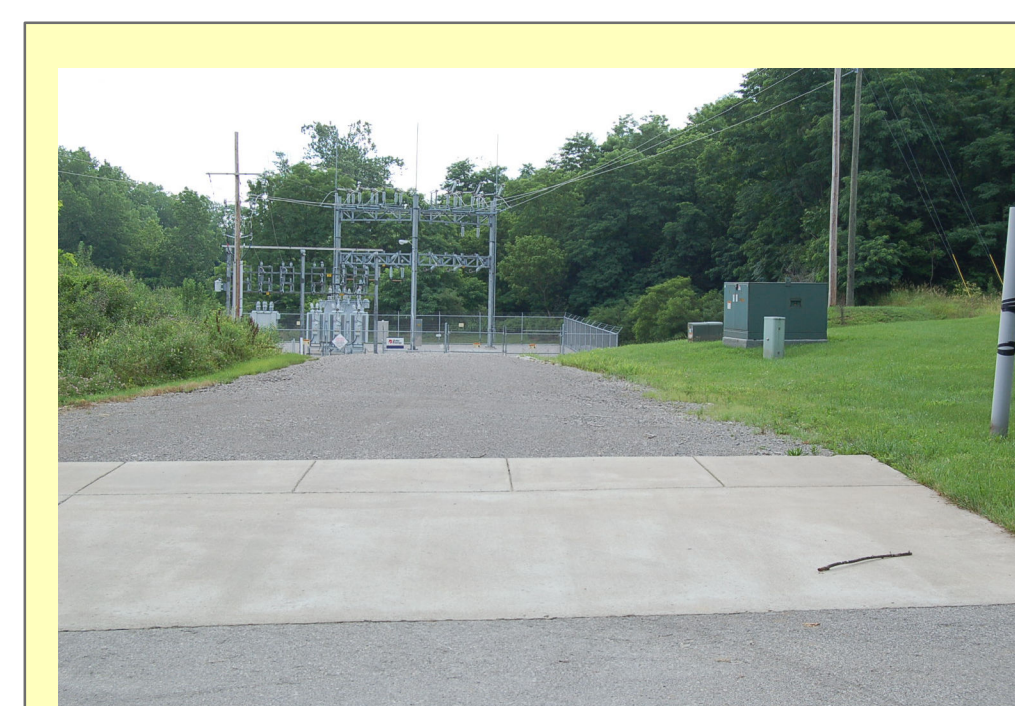
Small electric substation just north of the property.

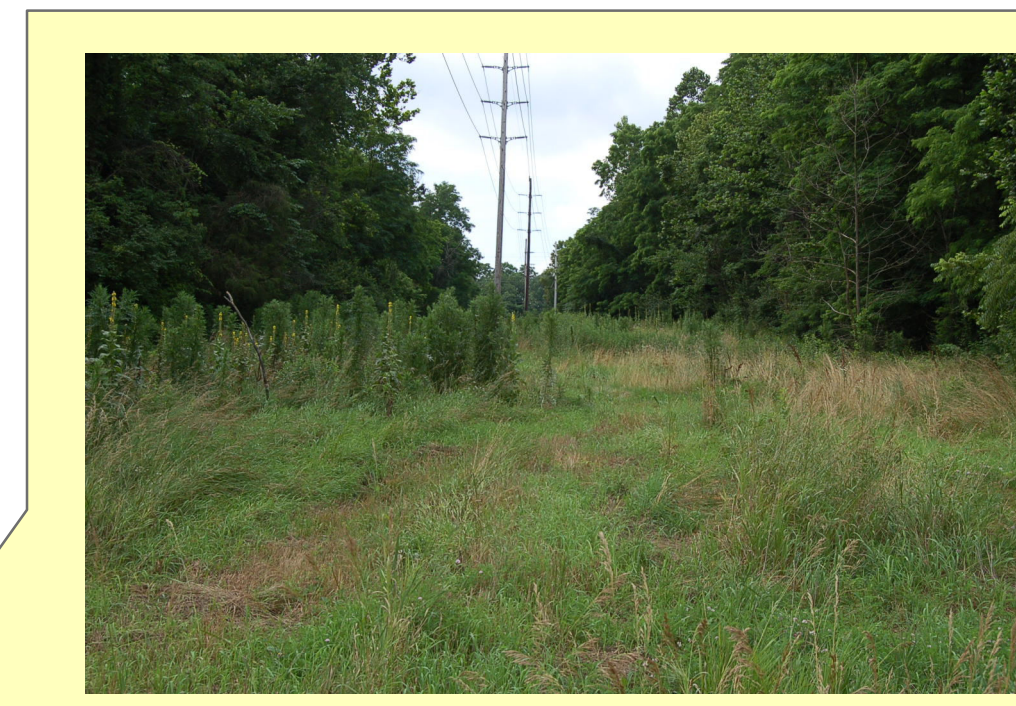
View south from substation along powerline right of way. This is characteristic of much of the property

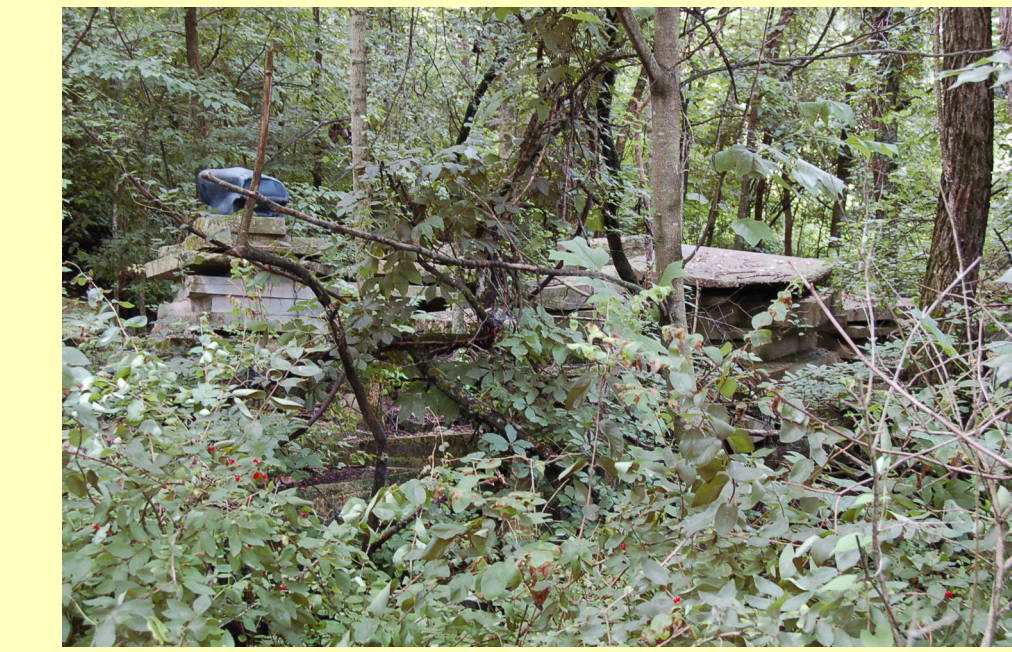
Standing in the power line cut, looking east, we see an example of the limestone rubble found in many of the forested areas on the property.

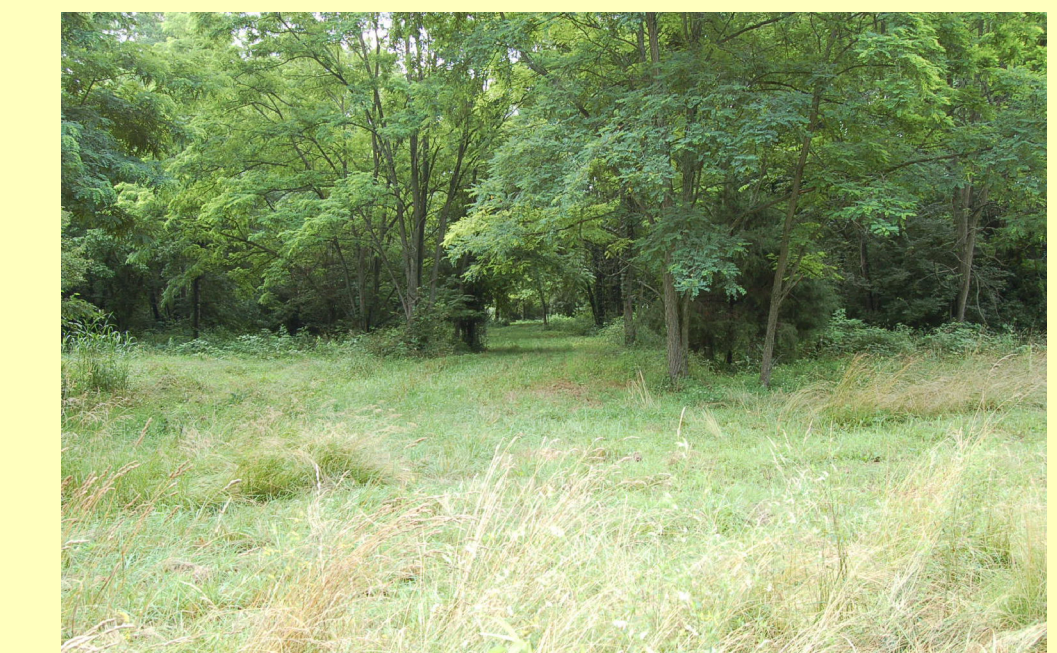
Standing in the power line cut, looking south-east. Young growth forest with a bit of clearing. This area has several old partially filled quarry pits.

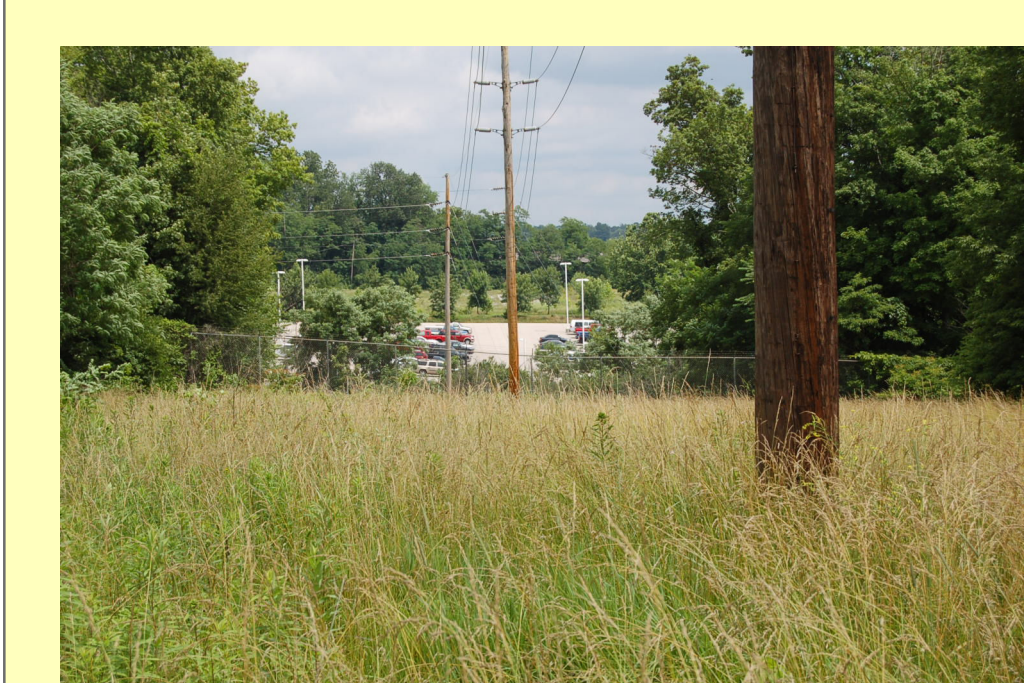
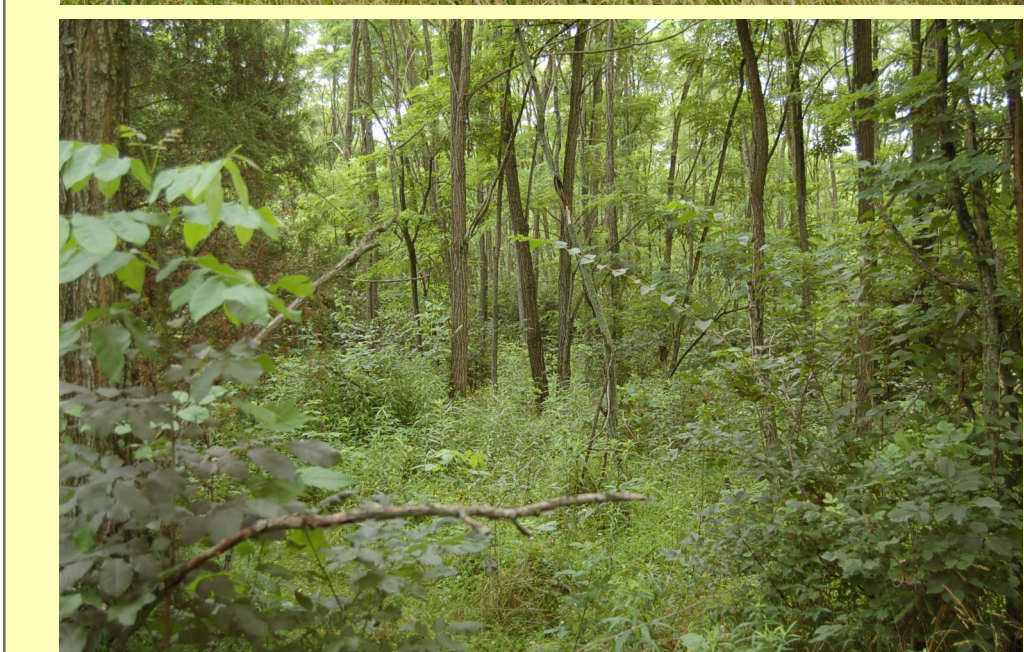
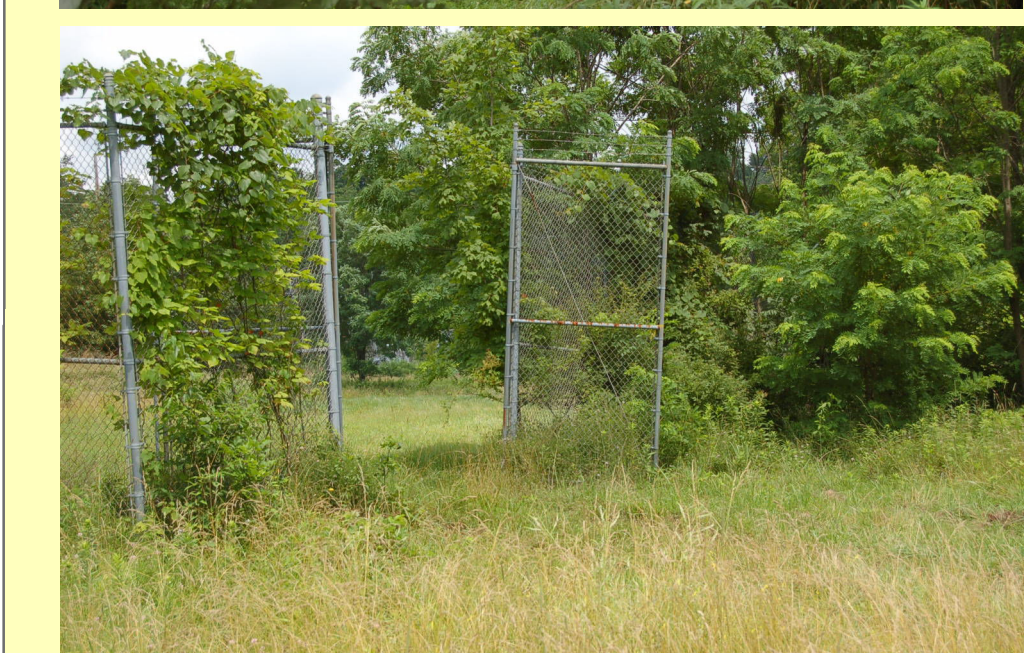
TOP: Looking north along the small powerline cut. The overflow parking lot on the Organized Living property can be seen.
MIDDLE: Young regrowth forest can be seen to the west.
BOTTOM: The gate of a fence around this small northern section of land.

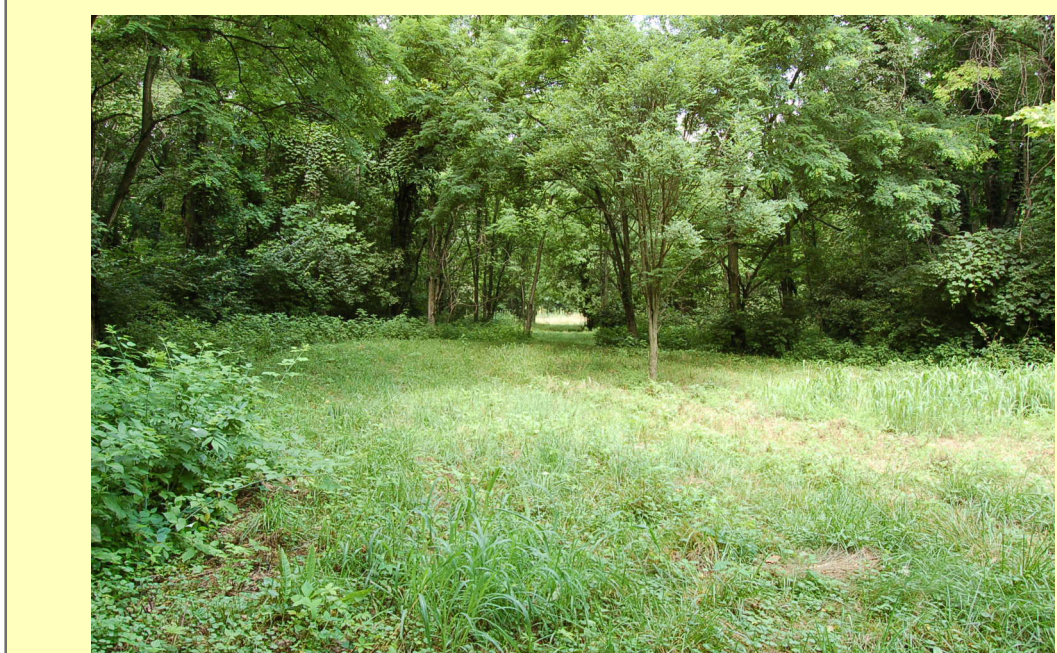
Standing in the clearing from the previous picture looking out either way (NW - top; SE - bottom). Immediately south of this point is the deepest quarry pit on the property.

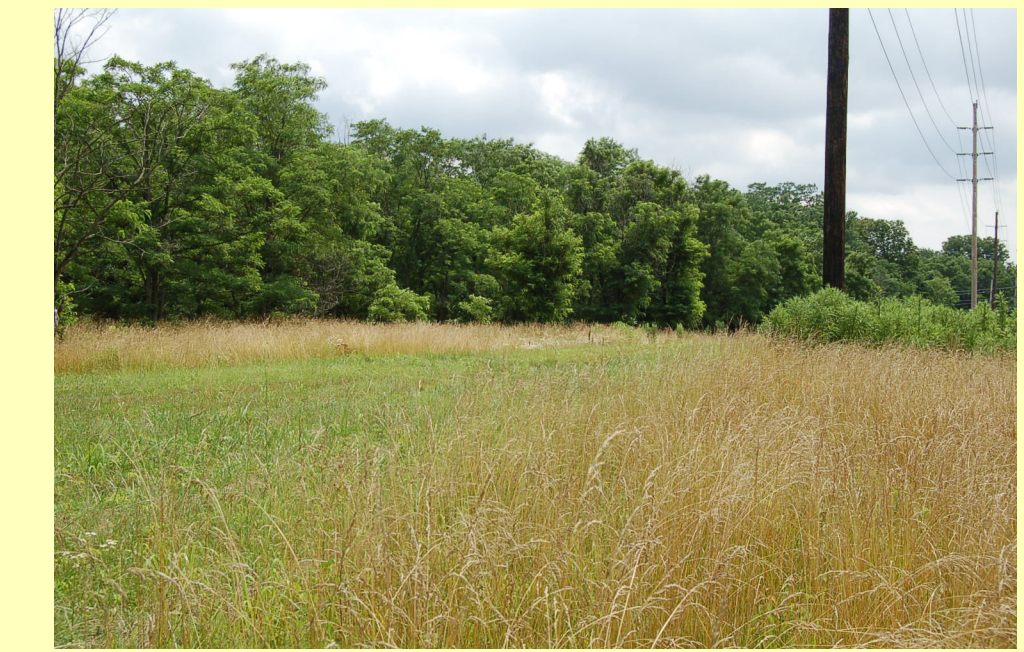
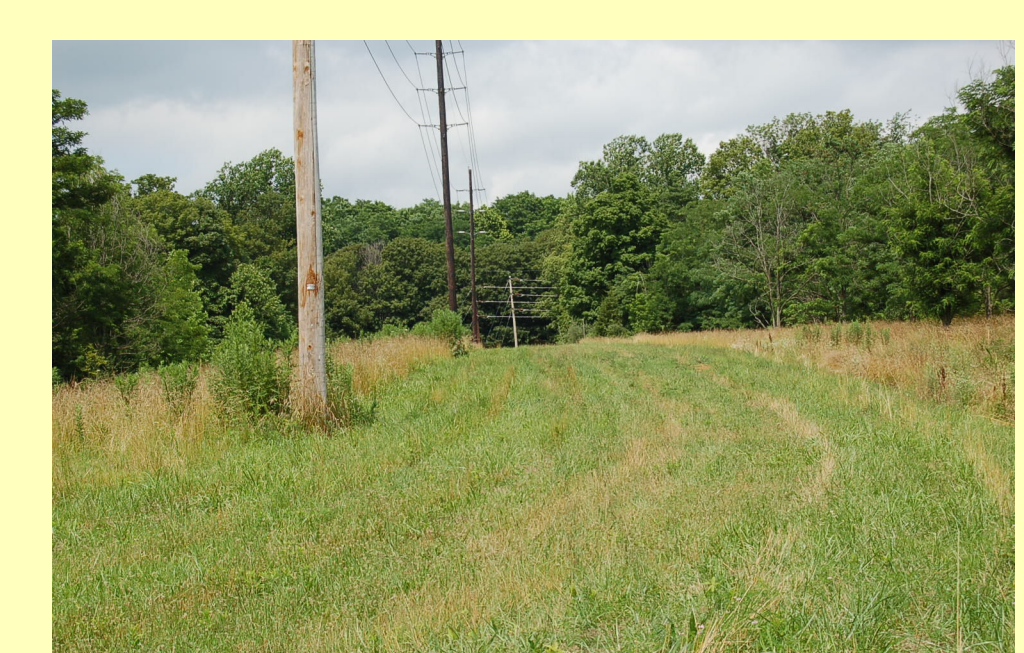
Nice meadow area under the smaller powerlines near the highest elevation on the property. Some erosion problems. Flanked by unnatural berms in areas. Slightly wetter soils.
TOP: Looking north
LOWER LEFT: Looking west
LOWER RIGHT: Looking east

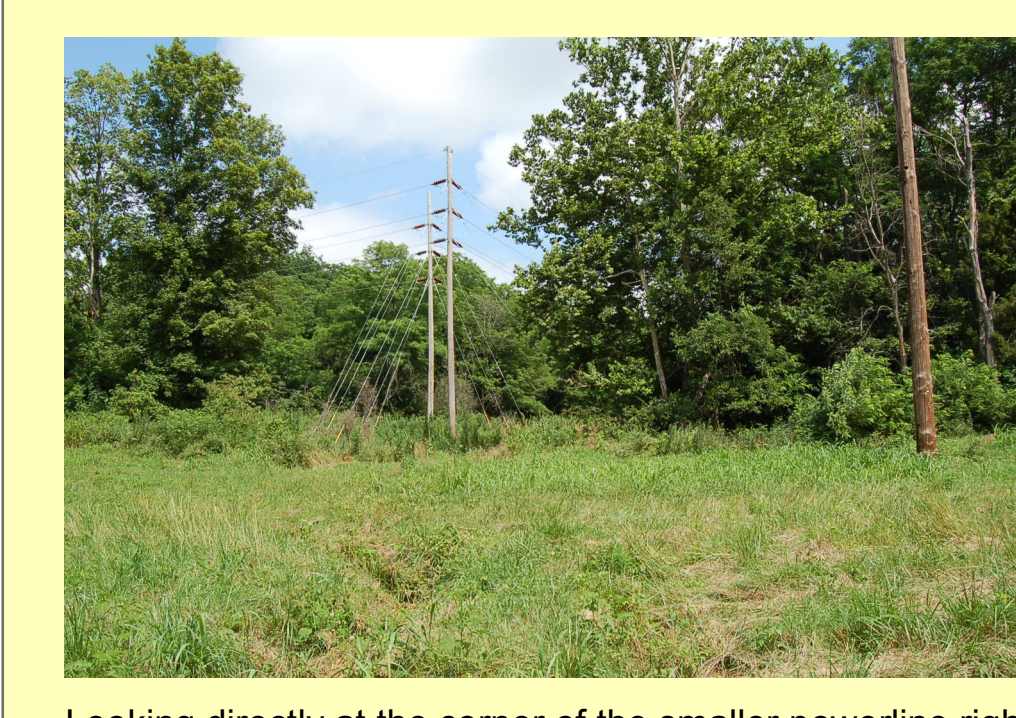
Looking directly at the corner of the smaller powerline right of way.

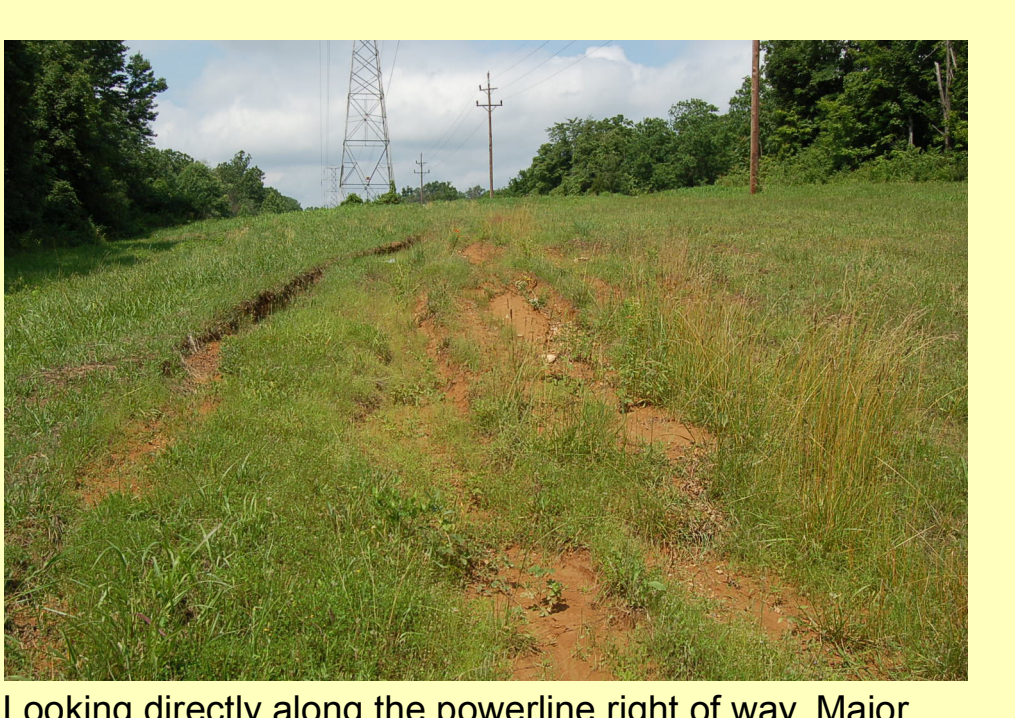
Looking directly along the powerline right of way. Major erosion on this slope, some ruts are a couple feet deep and wide.

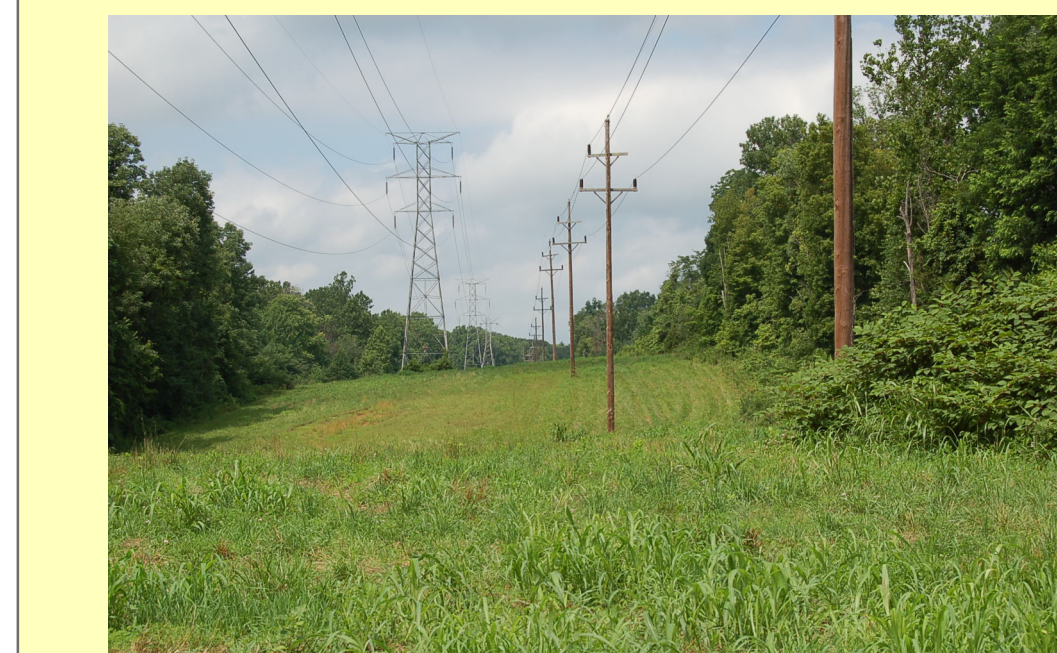
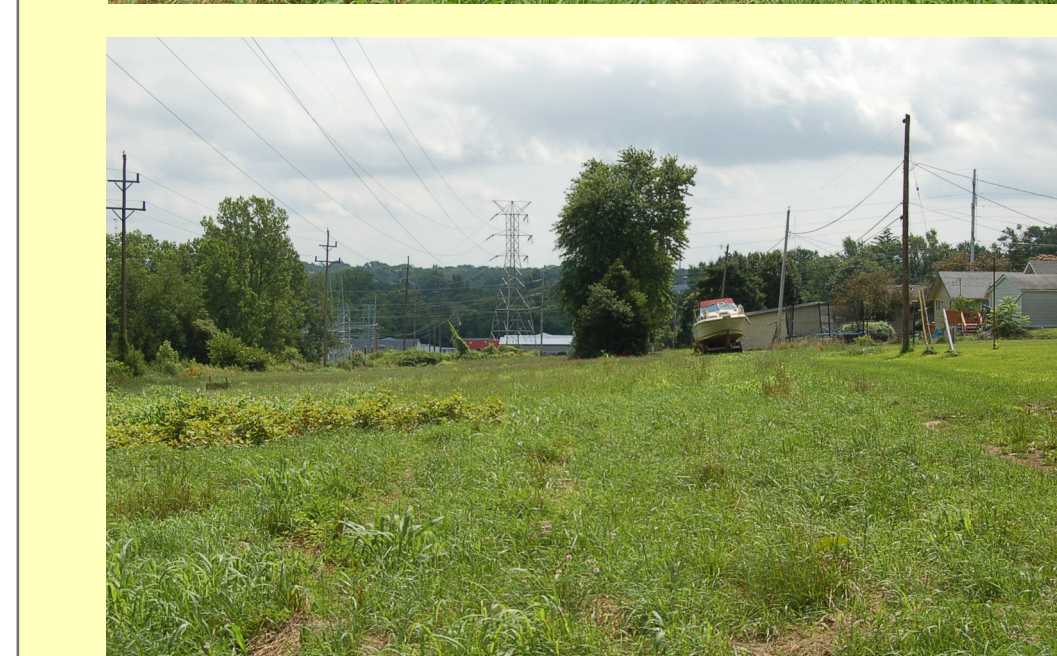
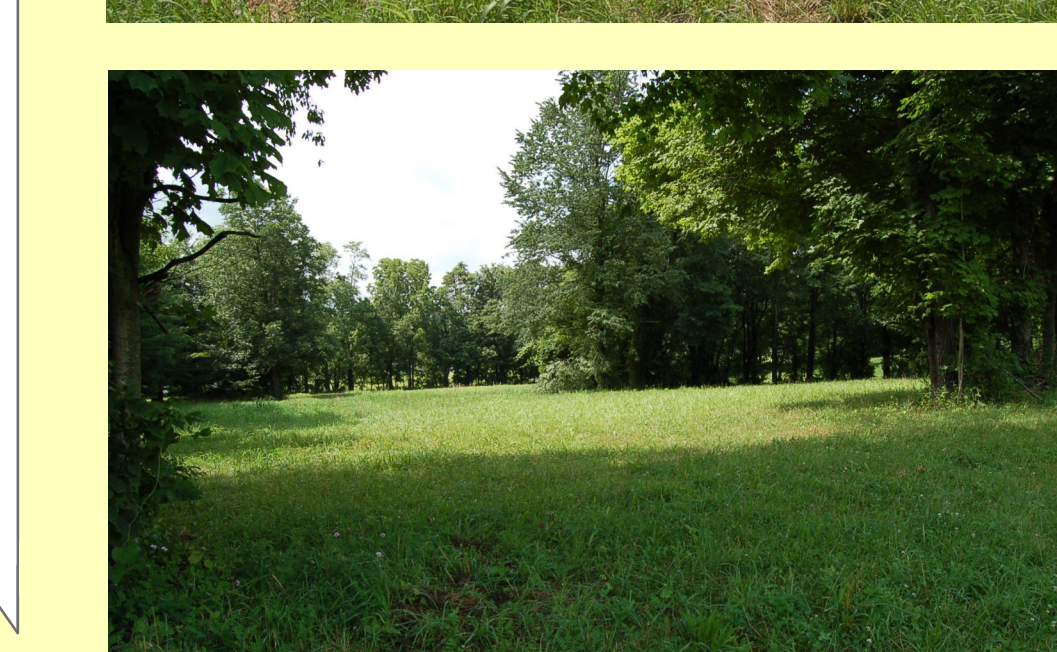
TOP: Standing in large powerline cut looking west across the property. Expansive open sloping field, with 2 power line systems to negotiate.
MIDDLE: From same spot looking east. You can see Broadview neighborhood to the south and Rogers Rd straight ahead in the distance. There is a dirt "road" behind the houses.
BOTTOM: From the same spot looking south. The shady meadow west of the neighborhood.
